Manhole Inspection Summary

Manhole # S11U__006MH

Insp Date: **12/9/08 2:49 PM**

Location Address: **1001 Wilso Dr.**

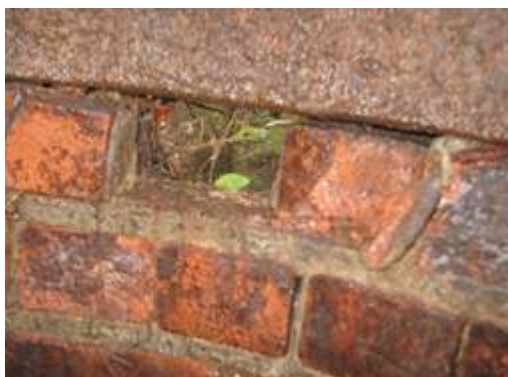
Defect 5

☒ **Deteriorated**

Chimney deteriorated

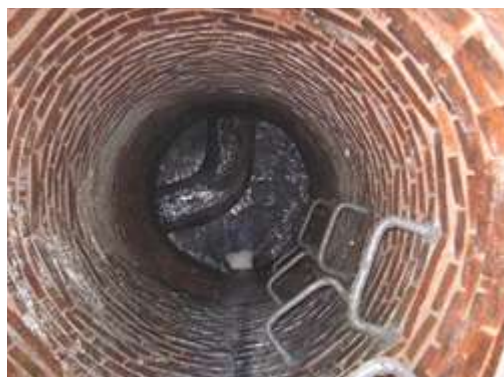
Defect 4

steps corroded

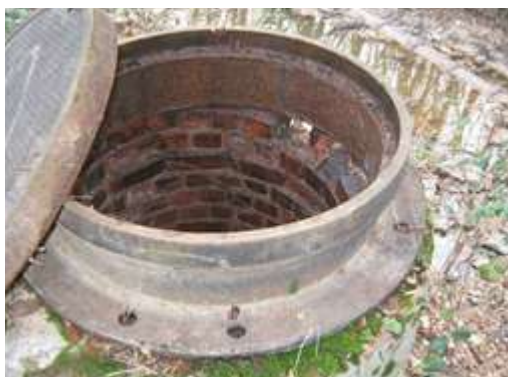
Defect 7

frame offset, frame leaks at cover

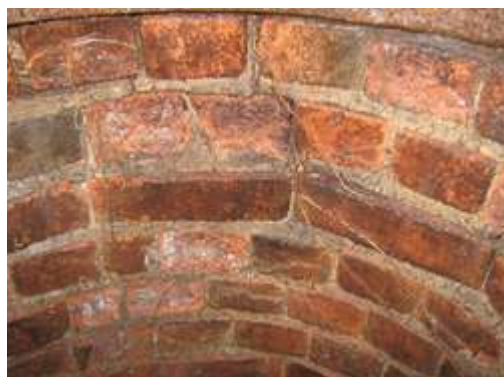
Defect 6

chimney infiltration at frame joint, roots, and wall

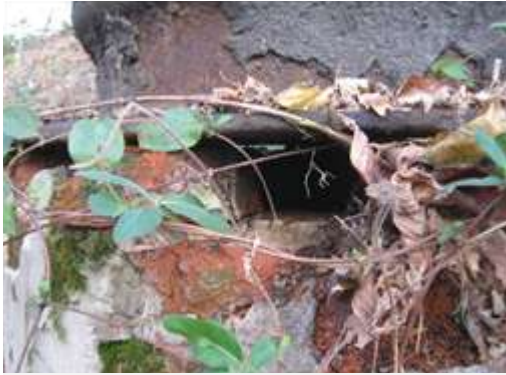
Defect 3

frame not attached; chimney loose bricks

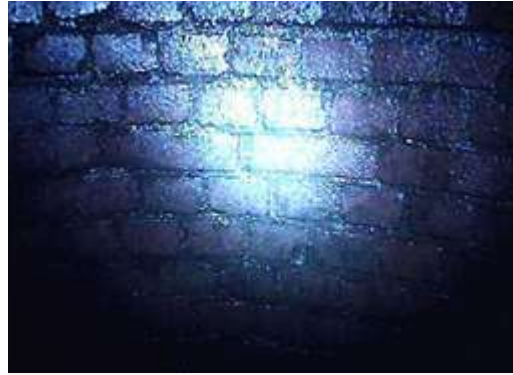
Defect 2

corbel infiltration at wall

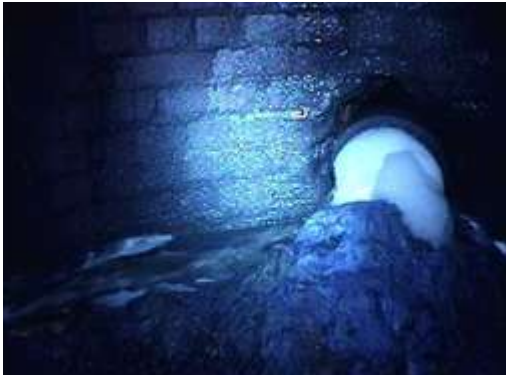
Defect 1

barrel infiltration at wall, barrel loose bricks, bench debris
